# Surface Analysis of OFE-Copper X-Band Accelerating Structures and Possible Correlation to RF Breakdown Events

S.E. Harvey\*, F. Le Pimpec, R.E. Kirby, F. Marcelja, K. Adamson, E.L. Garwin  
SLAC, 2575 Sand Hill Rd, Menlo Park, CA, 94025

2nd February 2008

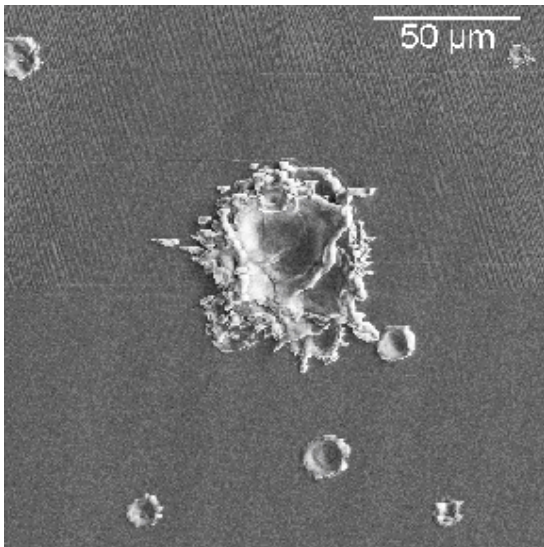
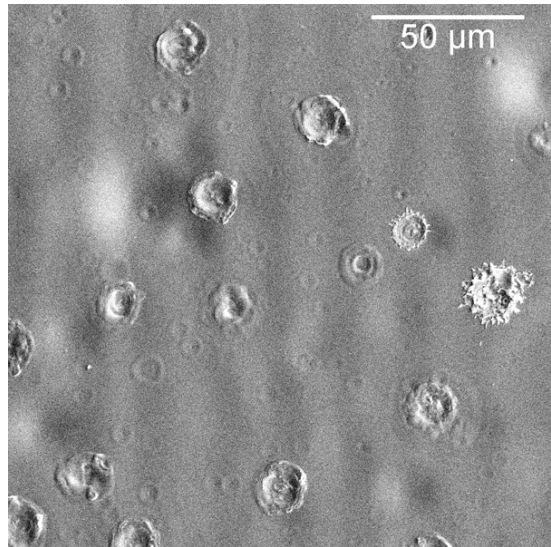
The defect dissipates some of the RF energy. Melting at the breakdown site creates craters that, due to their irregular geometry, can act as further sites for enhanced field emission and breakdown. The observed physical morphology of the craters falls into two distinct groups: irregular edges and softened edges. Fig.1(a) shows a crater with irreg-

ular edges; in Fig.1(b) a second type of crater is observed where there are few sharp edges and repeated melting appears to have taken place. The softened-edge craters often appear in close proximity with one another; irregularly edged craters are frequently spaced further apart. This suggests that the softened-edged craters may have started out irregularly edged, but have changed morphology due to repeated melting or plasma-ion bombardment.

Figure 1: (a) sharp-edged craters (left); (b) smoothed-edged craters (right)

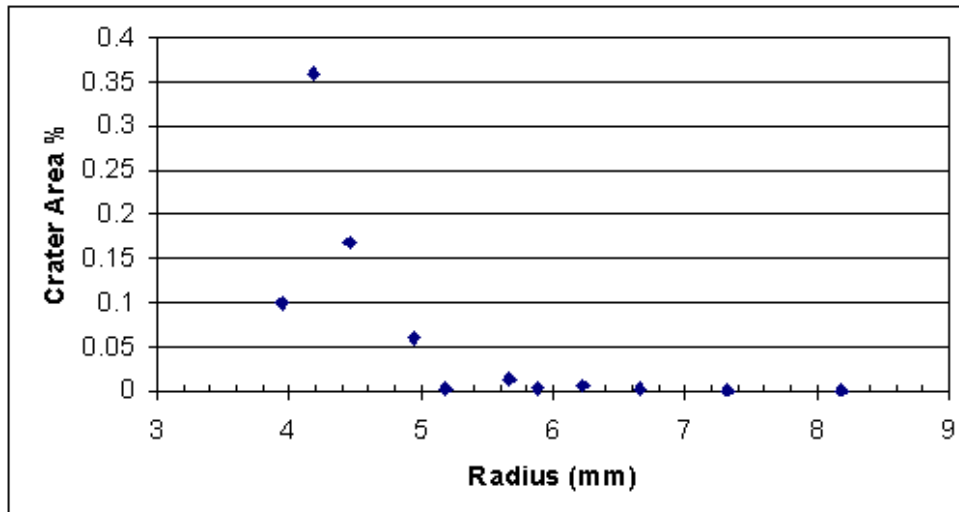
In general the density of craters increases along the cell radius toward the center, where electric fields ( $\mathbf{E}$ ) are highest, Fig.2. It is important to note that not every grain near the aperture exhibited craters and that the crater density varied substantially from grain to grain.

Figure 2: Average percentage area damaged by craters versus radial distance from center of aperture (30<sup>th</sup>Cell T53VG3RA)

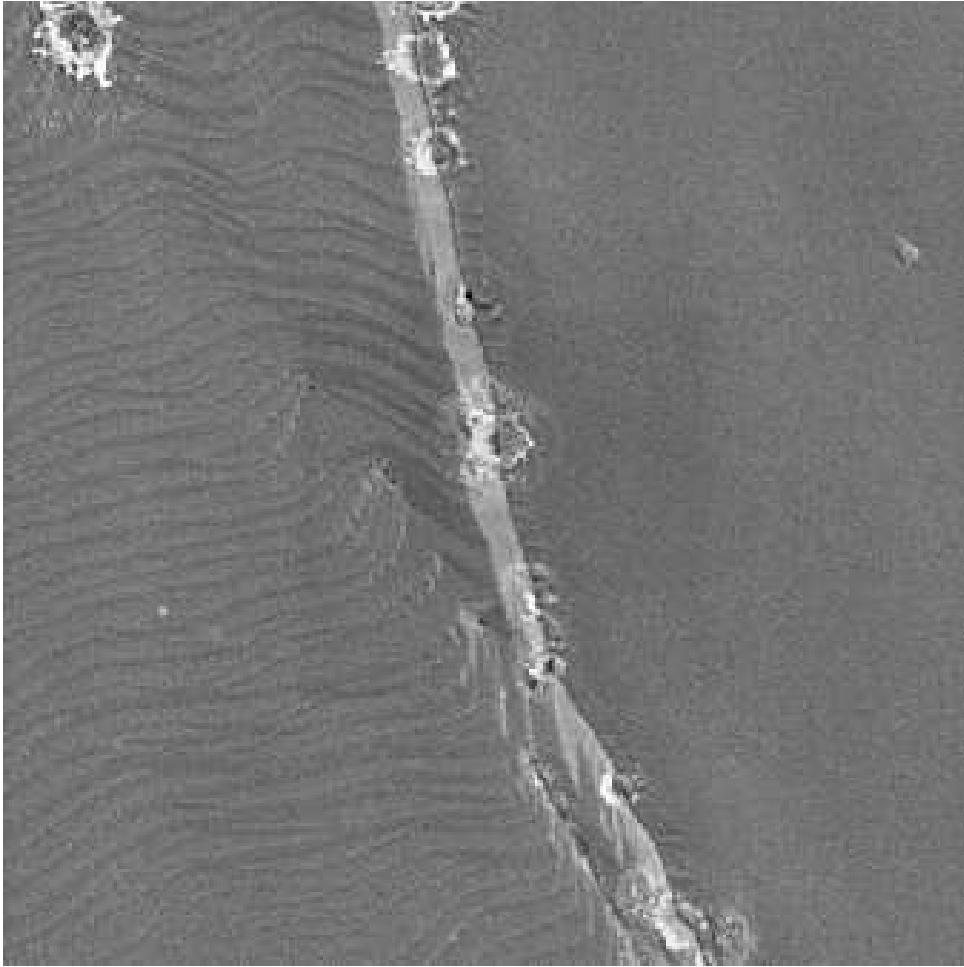
Craters were also seen at grain boundaries and at inclusions, Fig.4. Grain boundaries and inclusions are logical field emitters considering a Fowler-Nordheim model, equation.1. Both of these defect types have irregular geometries that increase the value of  $\beta$  (field-enhancement factor); simultaneously these defects indicate an area of high stress within the material, which could decrease the work function  $\Phi$ , increasing the field emission:

Of particular interest is the role of copper surface plasticity in RF breakdown. Local heating, as well as the presence of high magnetic and electric fields, are known to create mass movement in copper [9]. Inclusions emerging at grain boundaries and microprotrusions (slip lines), created by local stresses due to mass movement, can act as field emitters. So, there can be a sufficiently high field or local heating that could induce mass movement in copper, thus resulting in RF breakdown. Fig.4 does present mass move-

ment inside a grain, and a crater with no traces of contaminant. However, we have not correlated systematic mass movement in a grain with breakdown events.

Figure 4: Breakdown on Grain Boundary

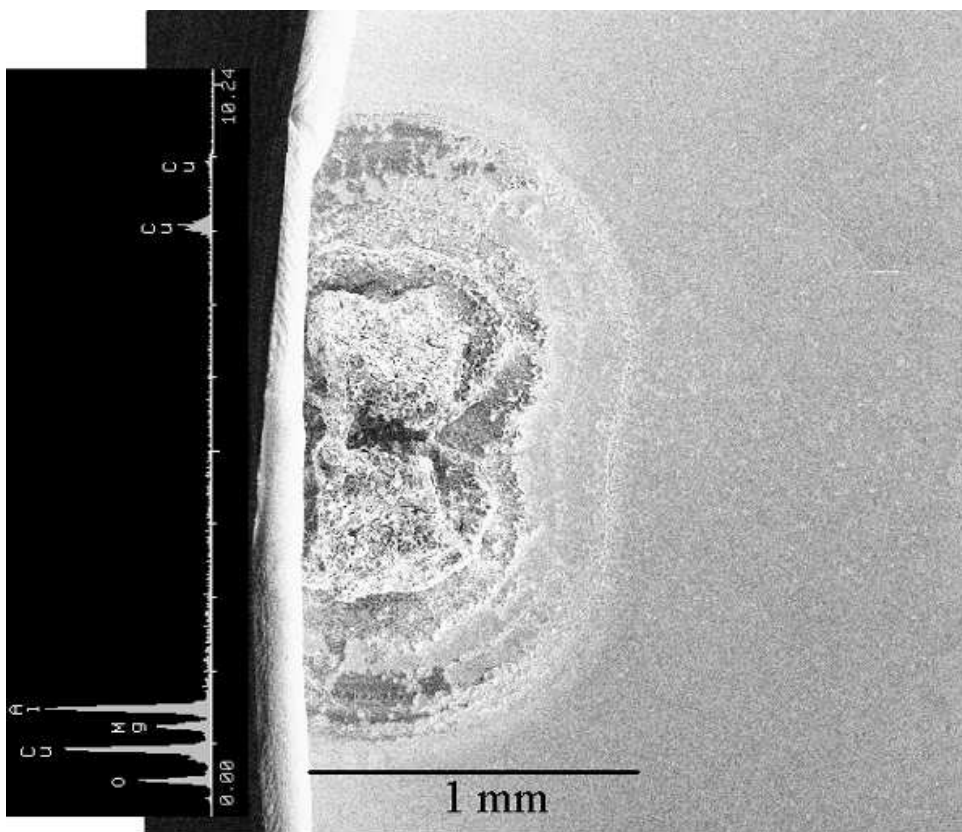
Two processed structures, H90VG5 and H90VG3N, did exhibit high RF breakdown in a localized region within the structure. At the bottom of the cell 13, between iris 12 and iris 13, of H90VG5, an aluminum sliver (mm length) was found, Fig.5. In cell 35-36 of H90VG3N a large ( $> 100$  microns) stainless steel (S/S) particle, Fig.6 was found embedded in the sidewall of the cell. A high density of craters was found near the S/S particle, Fig.7. The aluminium sliver was likely introduced to the structure during assembly in the NLTCA. The process by which the S/S particle was introduced inside the structure is not so clear because the particle is now actually embedded into the copper.

Using RF design simulation software the intensity of the magnetic or electric field inside a structure or a cell can be determined. At the location of the cup side the magnetic field ( $\mathbf{H}$ ) of the RF wave is maximal  $0.3 \text{ MA/m}$ , on the iris it can be up to 5 times less. The surface electric field on the iris is  $150 \text{ MV/m}$  and is  $7 \text{ MV/m}$  at the location of the S/S particle. The pattern of the melting at the base of this particle is consistent with a high current induced by  $\mathbf{H}$  [13].

Figure 5: Aluminum particle (melted due to RF breakdown?) found on cell 13 of H90VG5

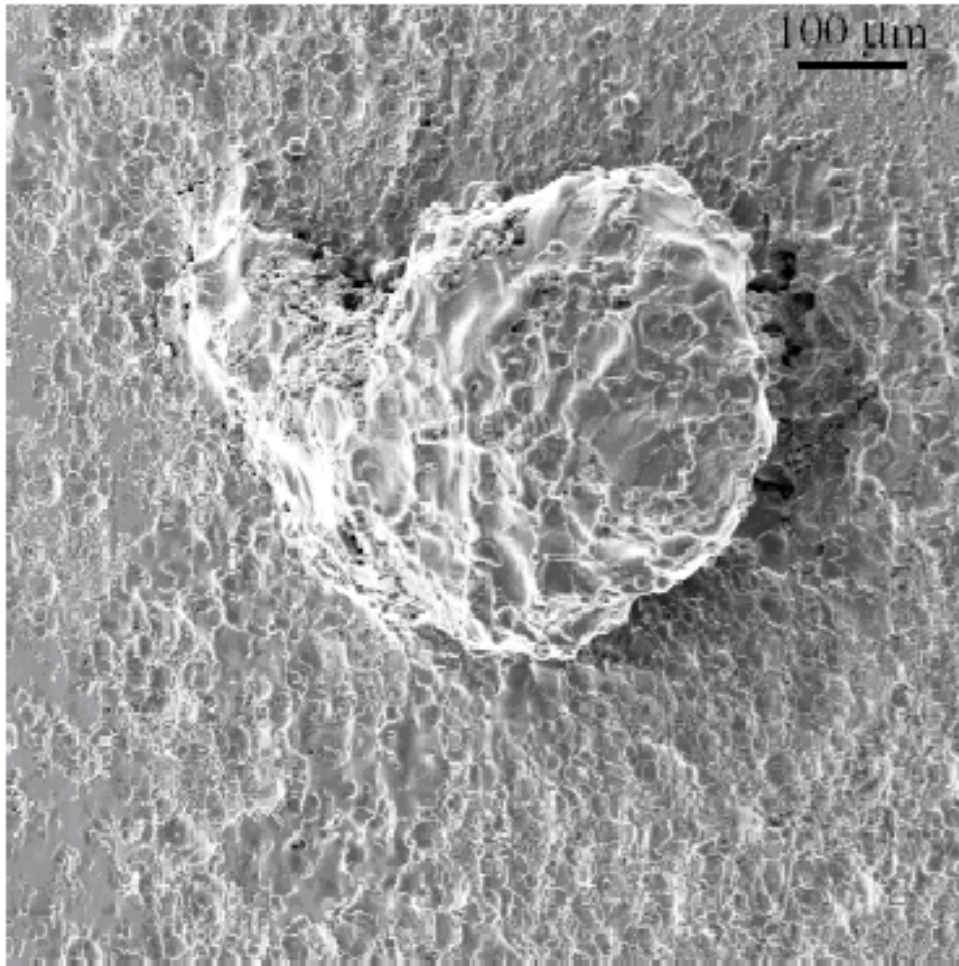
Figure 6: Stainless steel particle embedded in wall of H90VG3N

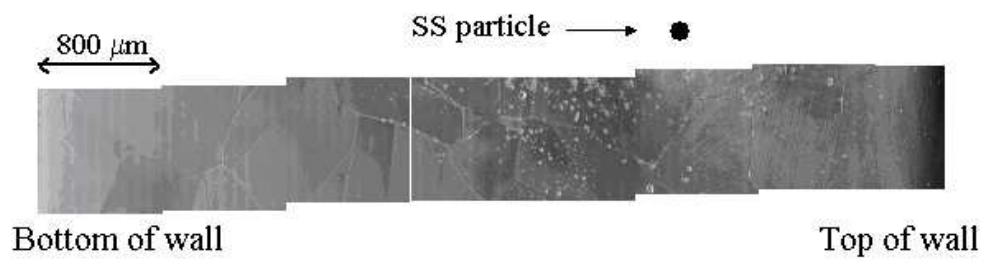
Figure 7: High density of RF breakdown events near stainless steel mushroom
